Harwin Test Report Summary

HT04401

Latch Integrity Testing of L-Tek
(M80 Series) Connectors

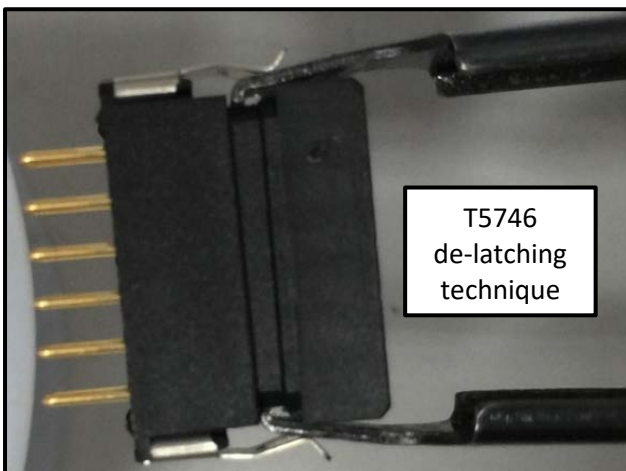
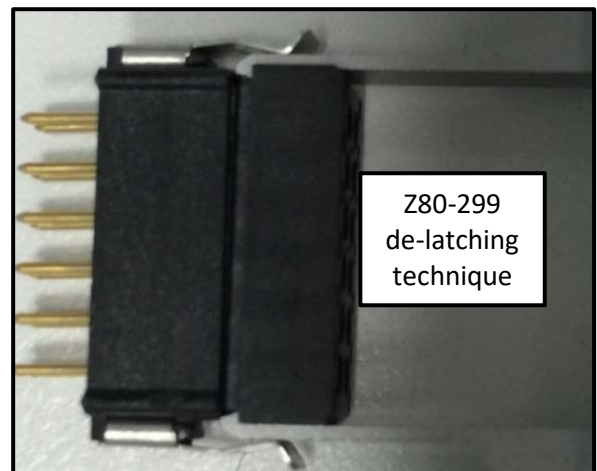
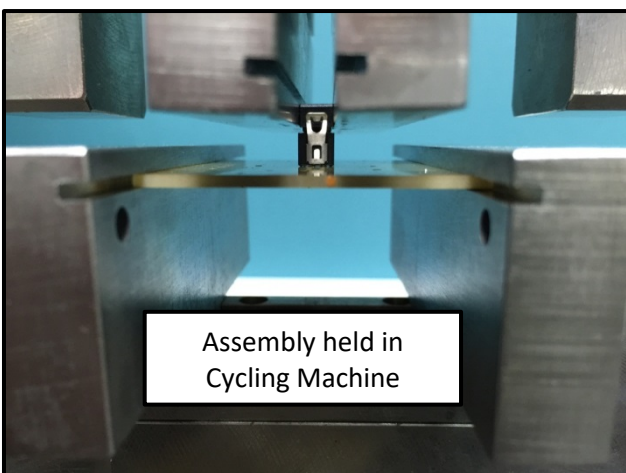
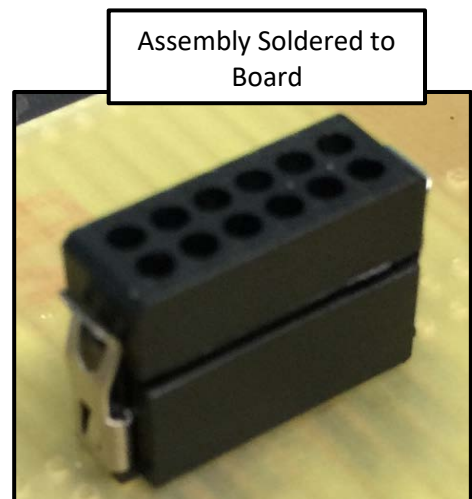
Tests performed
2.1. Pull-apart destructive testing of 12-position male and female connectors with female contacts removed so they do not affect the results. Connectors were separated with de-latching tool T5746 and cycled up to 20 times.
2.2. Pull-apart destructive testing of 12-position male and female connectors with contacts removed so they do not affect the results. Connectors were separated with de-latching tool Z80-299 and cycled up to 15 times.

- 3.1. Pull-apart destructive testing of a 12 way latched connector, with the contacts removed from the female moulding. Connectors were cycled in increasing number of separations using tool T5746 to de-latch then after each specified number of separations, the mated pair was then separated without using a de-latching tool. The force required was measured by the P337 Lloyds Cycling Machine, and recorded in the table below.

- 3.2. The typical mode of failure was that the Latch locking feature broached through the plastic of the female moulding. The Male latch remained intact but slightly bent.
- 3.3. Test was then repeated for 15 separations using tool Z80-280.

- 3.4. The typical mode of failure was that the Latch locking feature broached through the plastic of the female moulding. The Male latch remained intact but slightly bent.
