Harwin Test Report Summary

HT06901

Gecko Cable Assembly
Backpotting Temperature Testing

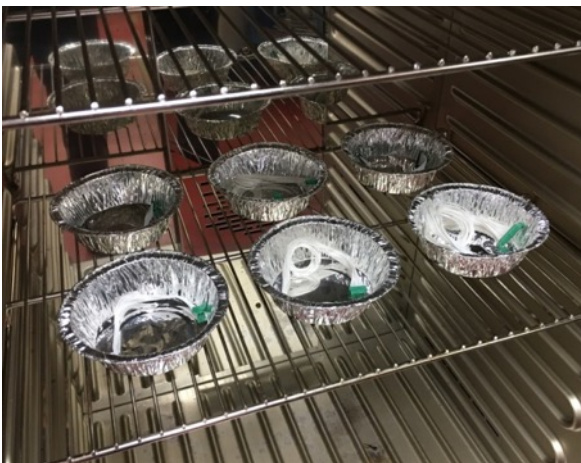
Figure 1- Arrangement of samples within the Industrial Oven.

To ensure the cable assemblies are capable of withstanding the temperature requirements of the Gecko Component Specification C125XX, the samples were subjected to +150°C for 100, 250 and 1000 hours.

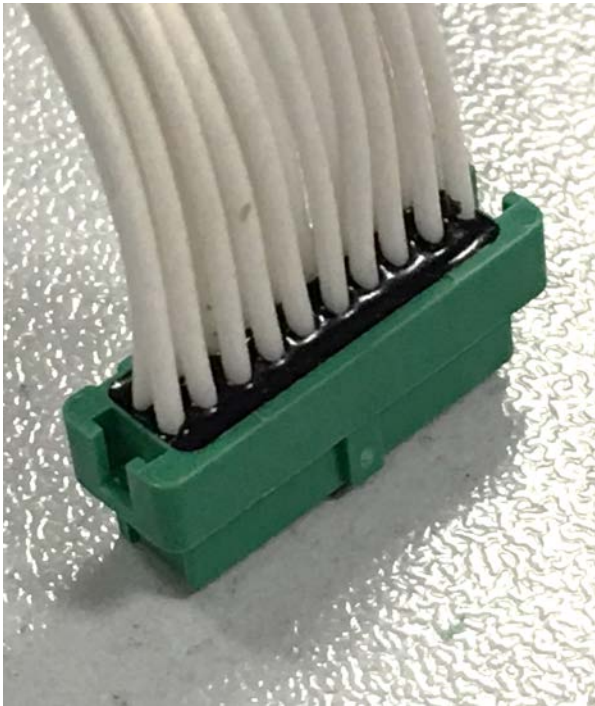
Figure 2- G125-FC12005L0-0300F prior to testing.

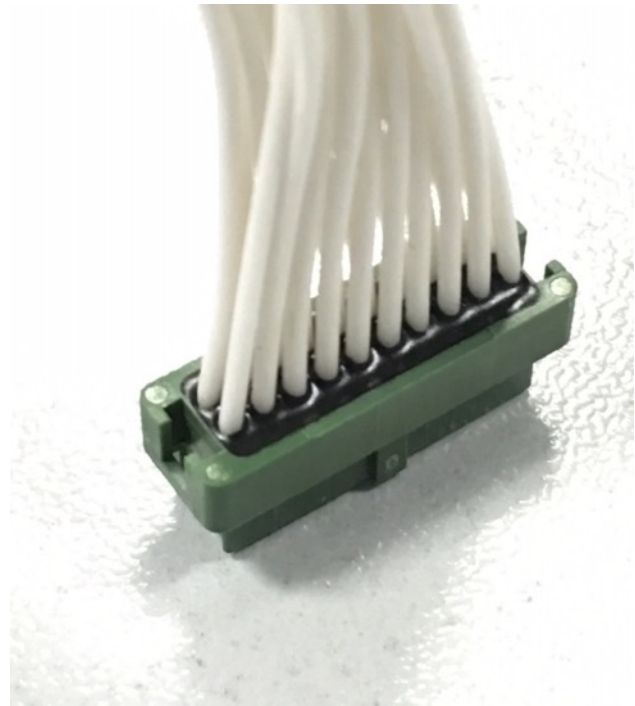
Figure 3- G125-FC12005L0-0300F after 100 hours at +150°C.

The compound appearance became dull but remained uncracked and unblistered.

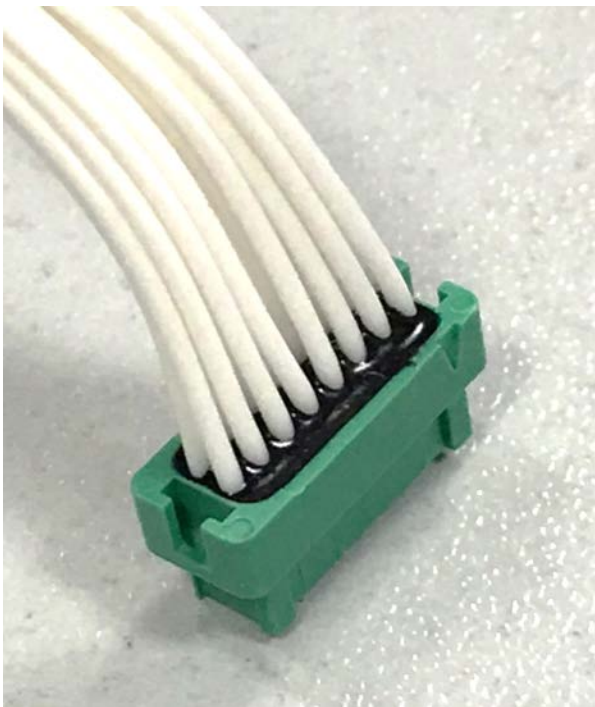
Figure 4 - G125-FC11605L0-0150F prior to testing.

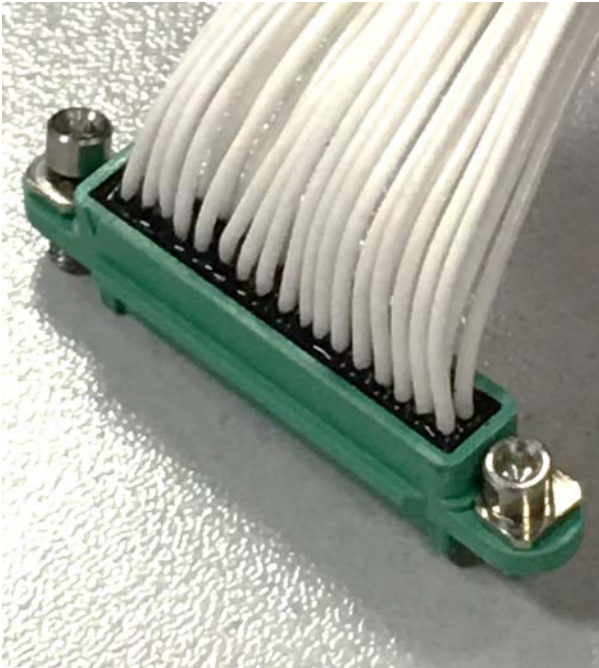
Figure 6- G125-FC13405F1-0300F1 prior to testing.

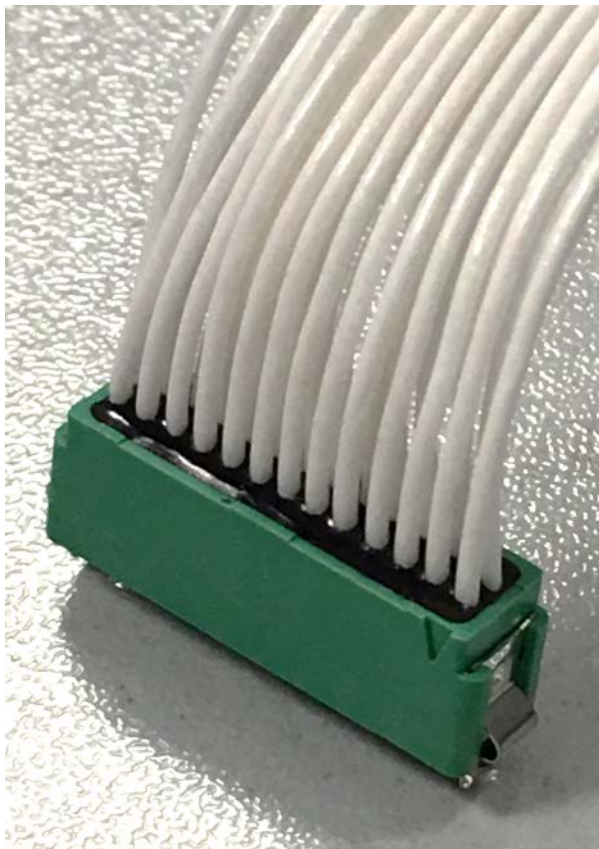
Figure 8- G125-FC12605F1-0150F prior to testing.
